CALIFORNIA DIVISION OF MINES AND GEOLOGY

FAULT EVALUATION REPORT FER-135

September 30, 1982

Chianti, Healdsburg, Alexander, Maacama, and related faults.

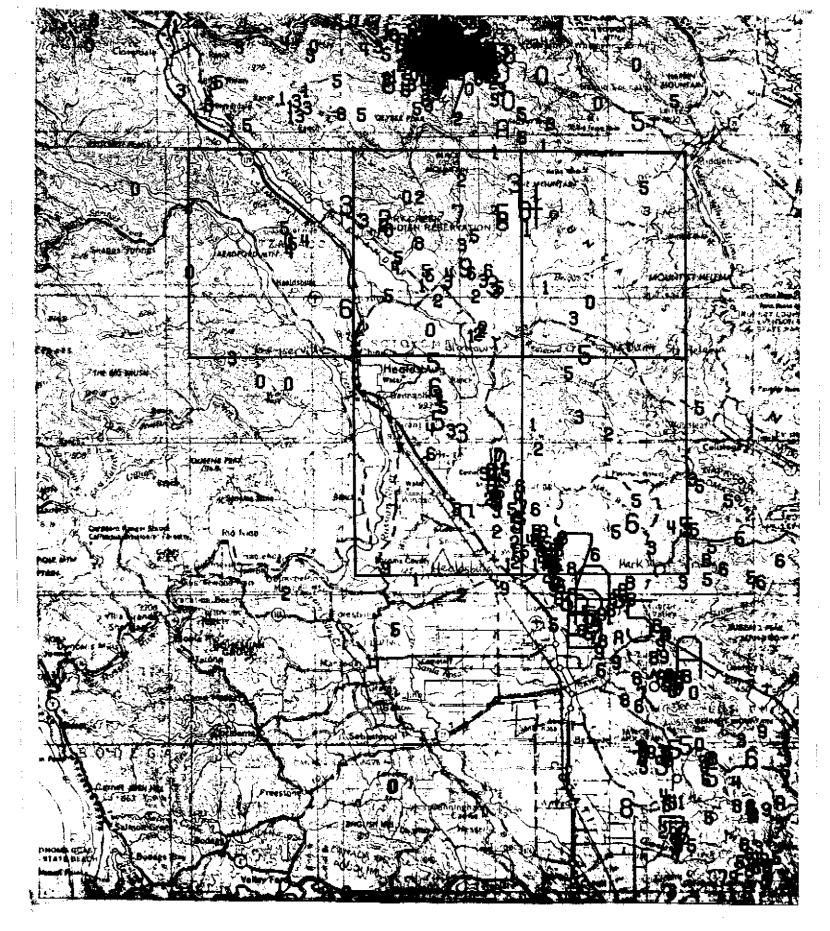
Microseismicity within and just south of the FER study area is depicted on figure 3 (Marks and Bufe, 1978). The Rodgers Creek fault zone is

fairly well-defined by the seismicity. Earthquakes of M5.6 and M5.7 occurred near Santa Rosa in 1969 and are clearly associated with the Rodgers Creek-Healdsburg fault zone. North of the area near Chalk Hill Road (figure 2b), the seismicity begins to trend more northerly toward the Maacama fault zone. To the northwest, the seismicity aligns along the Maacama fault zone. Fault plane solutions along the Maacama fault zone in the FER study area are consistent with right-lateral strike-slip faulting (Bufe, et al., 1981) (figure 4).

Figure 3 (to FER-135). Map of the seismicity of the FER area and surrounding region for the period January 1969 to June 1977. From Marks and Bufe (1978) (scale 1:250,000).

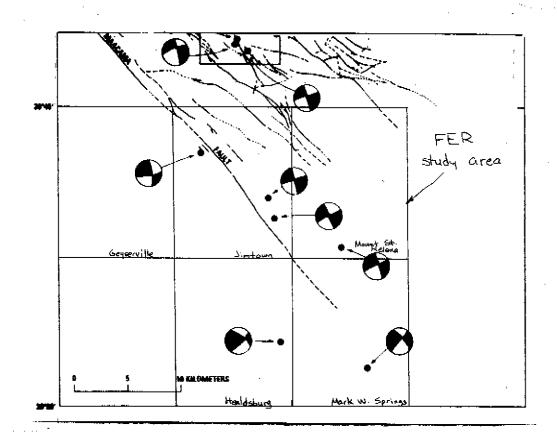
Figure 4 (to FER-135). Fault plane solutions (lower hemisphere) for earthquakes along the Maacama fault zone. Compressional quadrants are shaded. From Bufe, et al (1981).
